SOUTHERN AREA GROUNDWATER INTERCEPTOR TRENCH CONSTRUCTION & INSTALLATION REPORT

DETREX RD/RA
SOURCE CONTROL AREA
DETREX FACILITY
ASHTABULA, OHIO
DOCKET NO. V-W-98-C-450

Detrex Corporation
Ashtabula, OH

January 2008

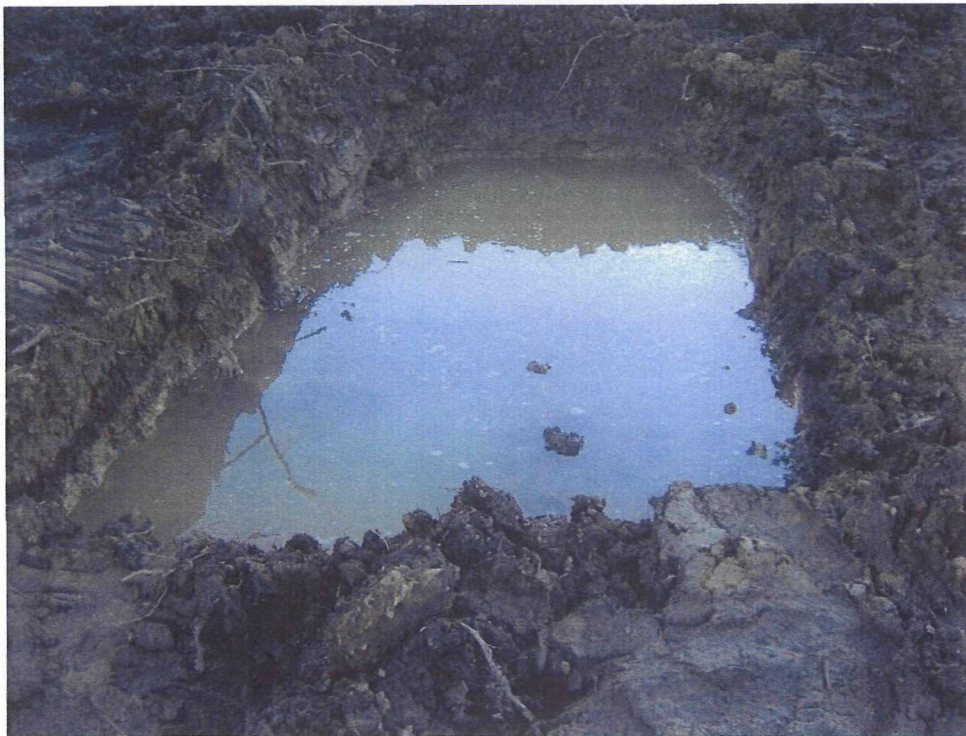
PHOTOGRAPH 35: A GWIT Sump hole was excavated north GWIT Sump #1 to collect surface water before it entered the installation location.

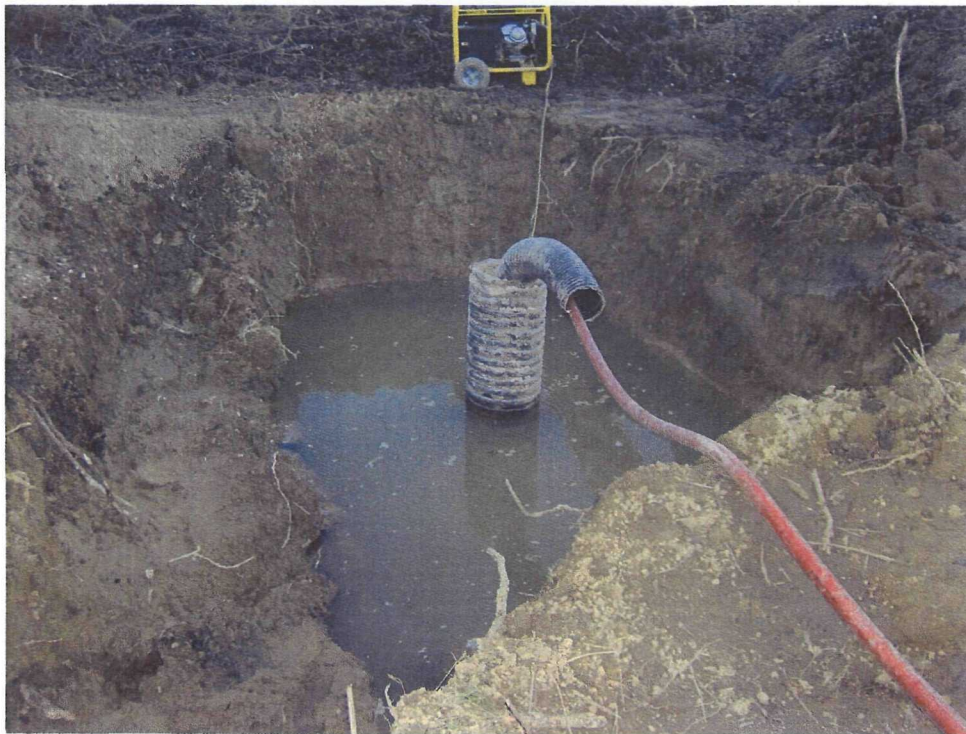
PHOTOGRAPH 36: Surface water released from the clay terracotta pipe was pumped from the GWIT Sump hole during the installation of GWIT Sump #1.

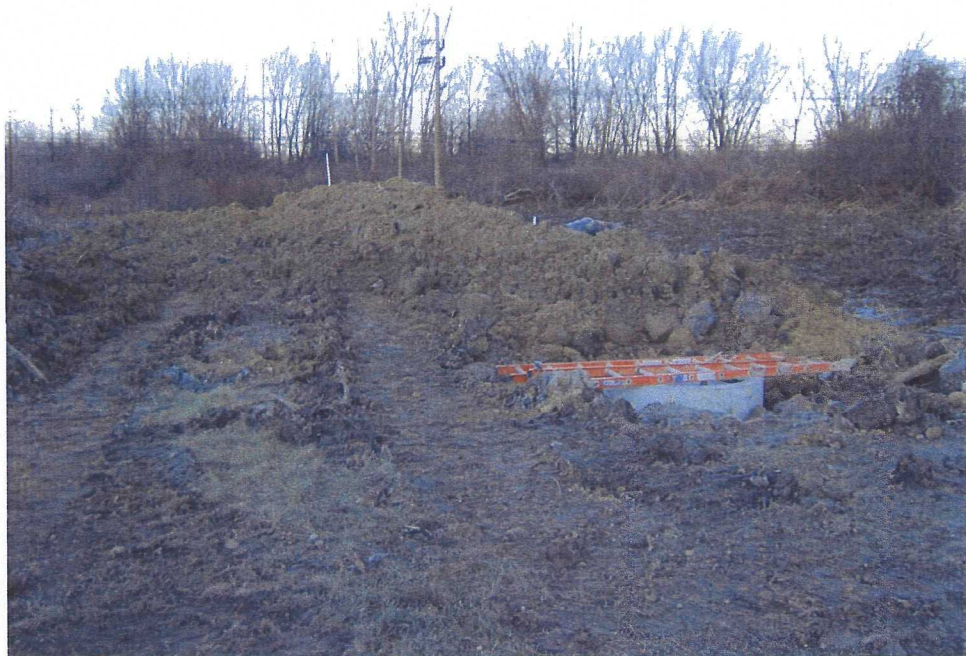
PHOTOGRAPH 37: West of GWIT Sump #3 after the GWIT collection system was installed and backfilled. Note the sample well located at the west limit of the GWIT collection system close to State Road.

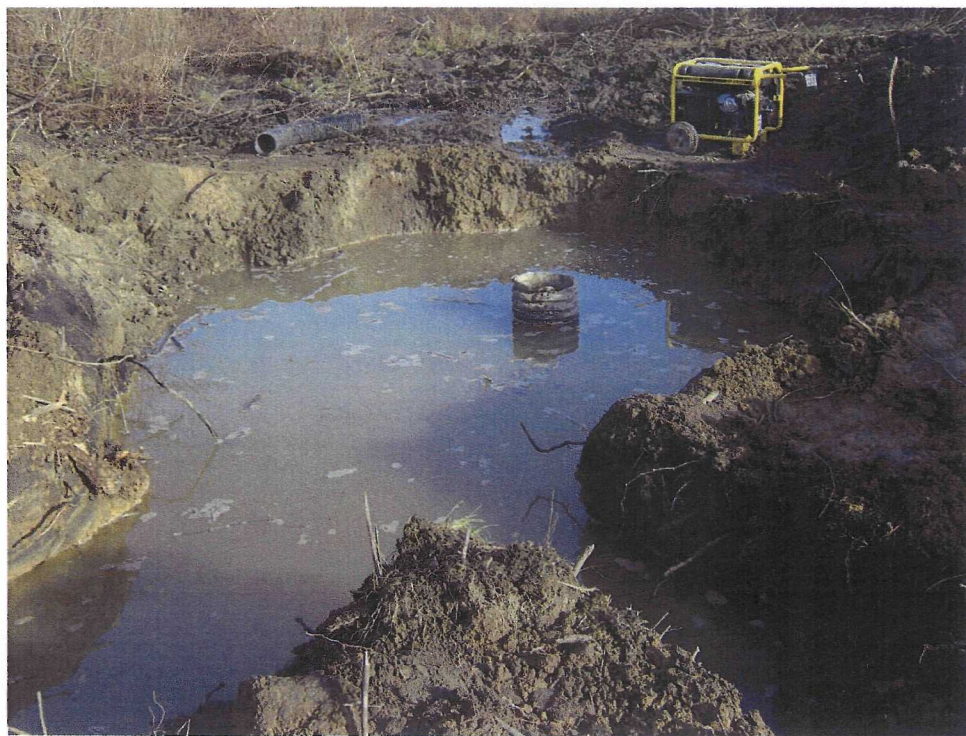
PHOTOGRAPH 38: Surface water that was accumulating in the GWIT Sump hole during the installation of GWIT Sump #1 and the GWIT collection system

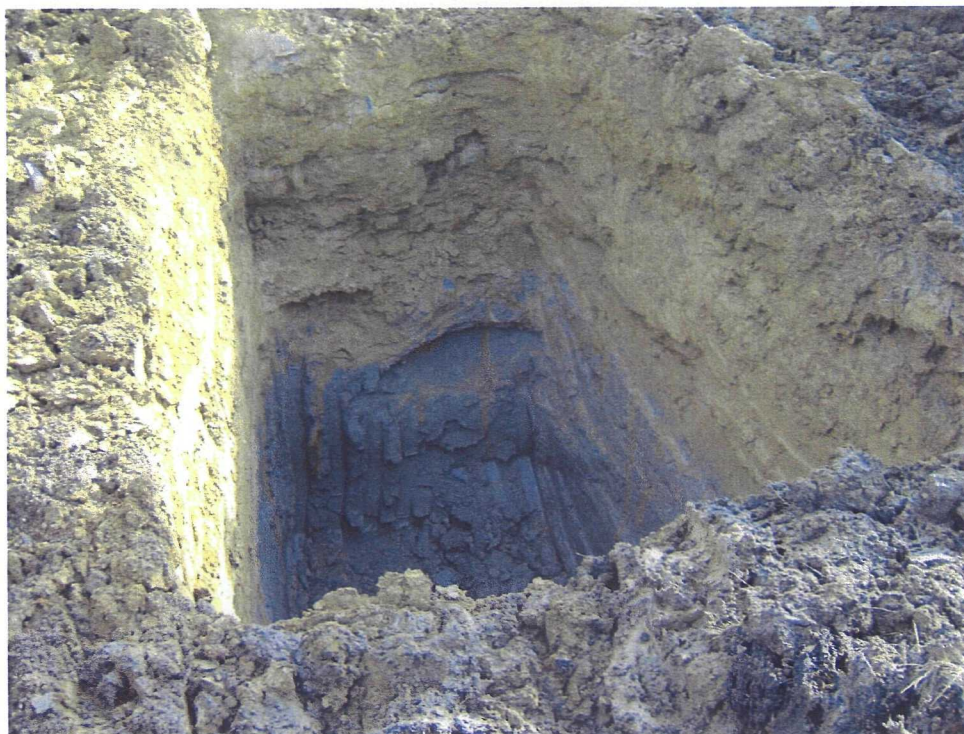
PHOTOGRAPH 39: Excavation for the installation of GWIT Sump #1. Note the gray glacial till layer visible at the base of the excavation.

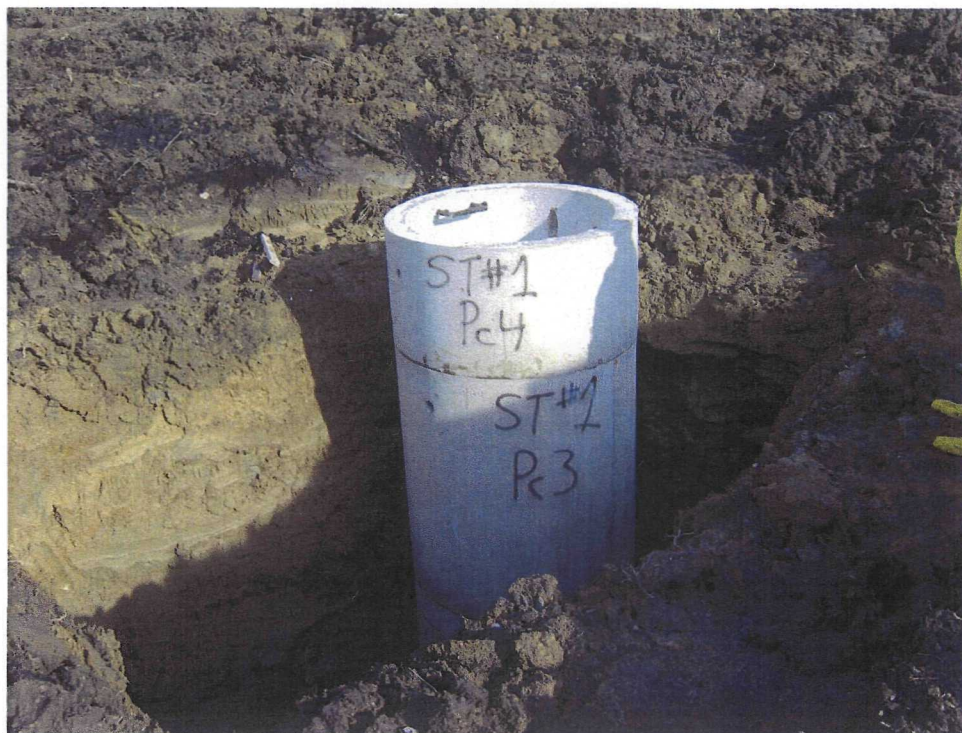
PHOTOGRAPH 40: Final placement of four sections of GWIT Sump #1.

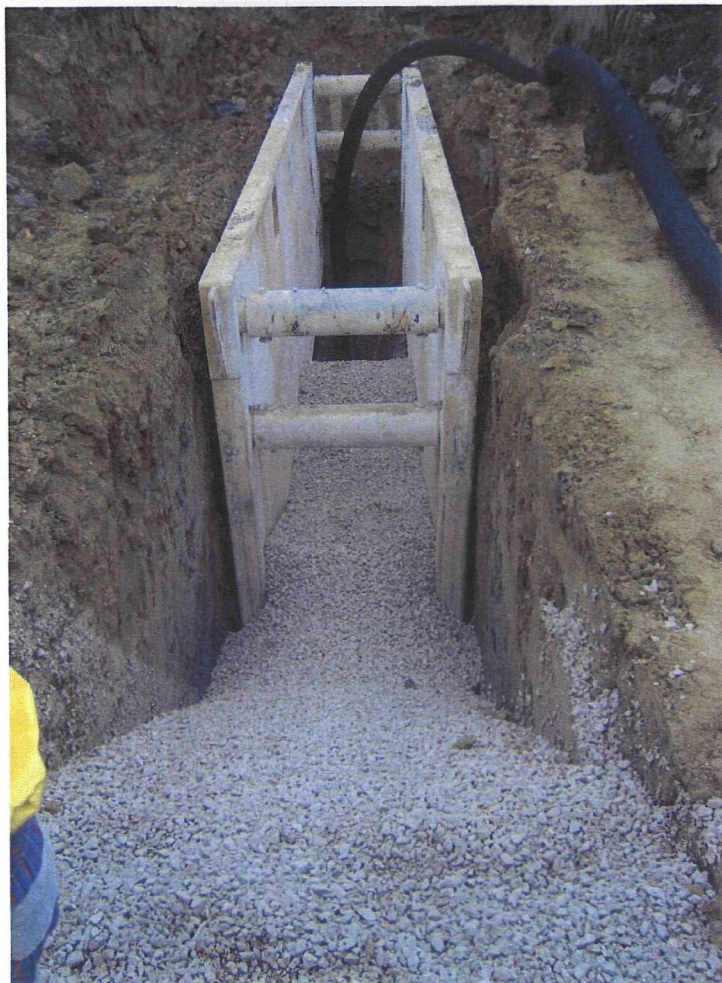
PHOTOGRAPH 41: GWIT collection pipe installation extending east of GWIT Sump #1. Note the GWIT pipe extending out of the trench box.

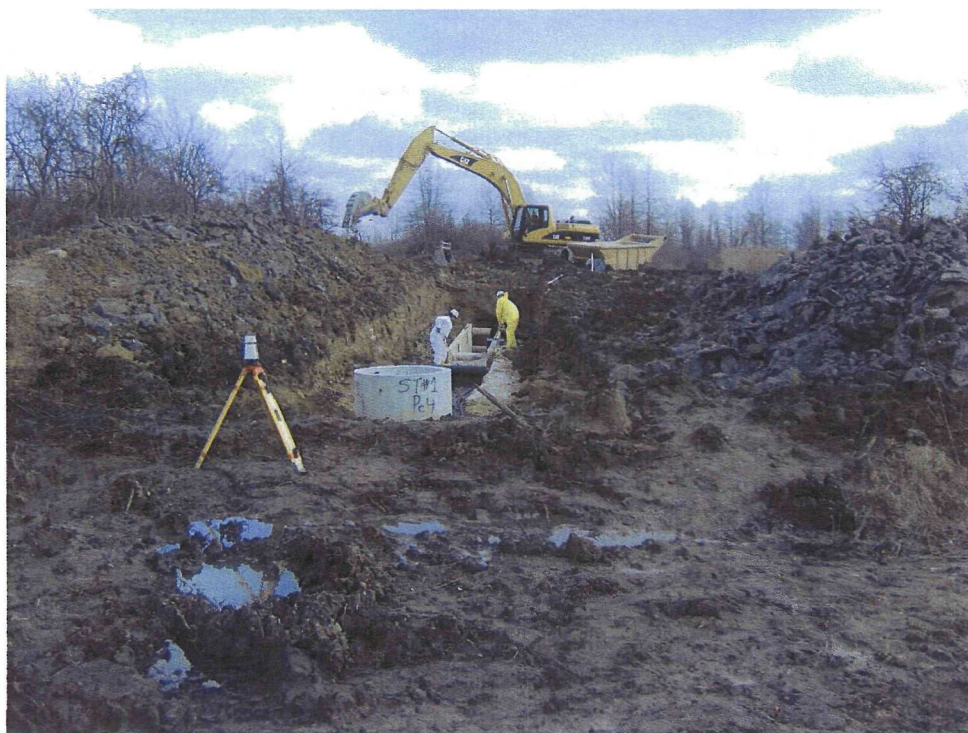
PHOTOGRAPH 42: Perspective photograph of the installation of the GWIT collection system extending east from GWIT Sump #1. Note the laser level used to place GWIT Sump #1 and maintain a 5% grade used to install GWIT pipe.

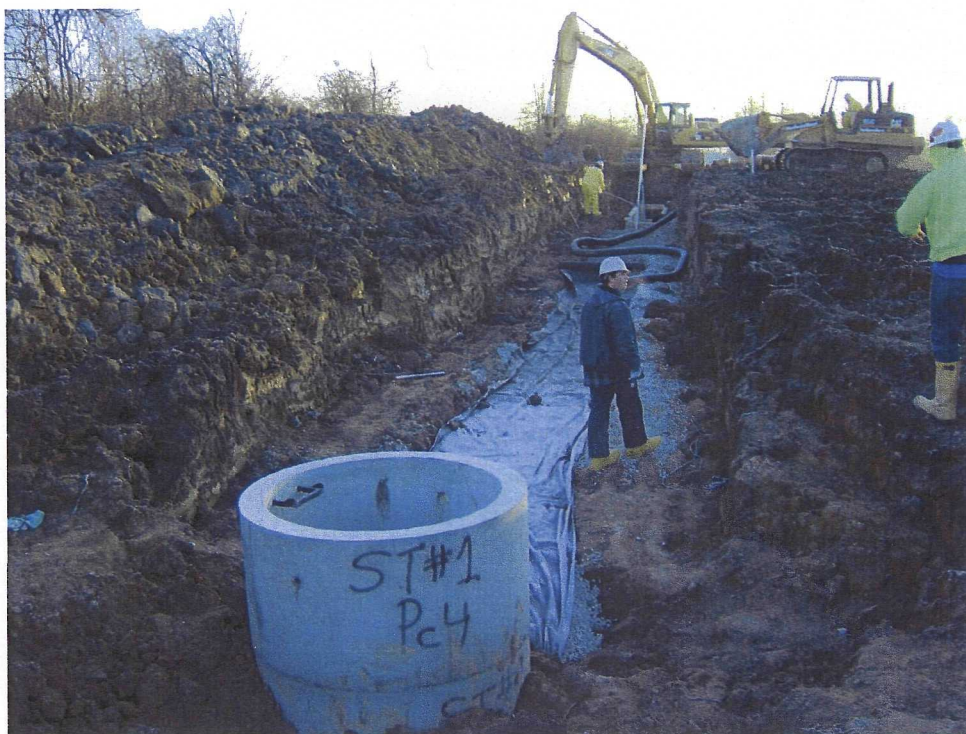
PHOTOGRAPH 43: Section of GWIT collection system is installed east of GWIT Sump #1. Pipe has been laid at grade, backfilled with gravel to within 4' of grade and filter fabric has been placed.

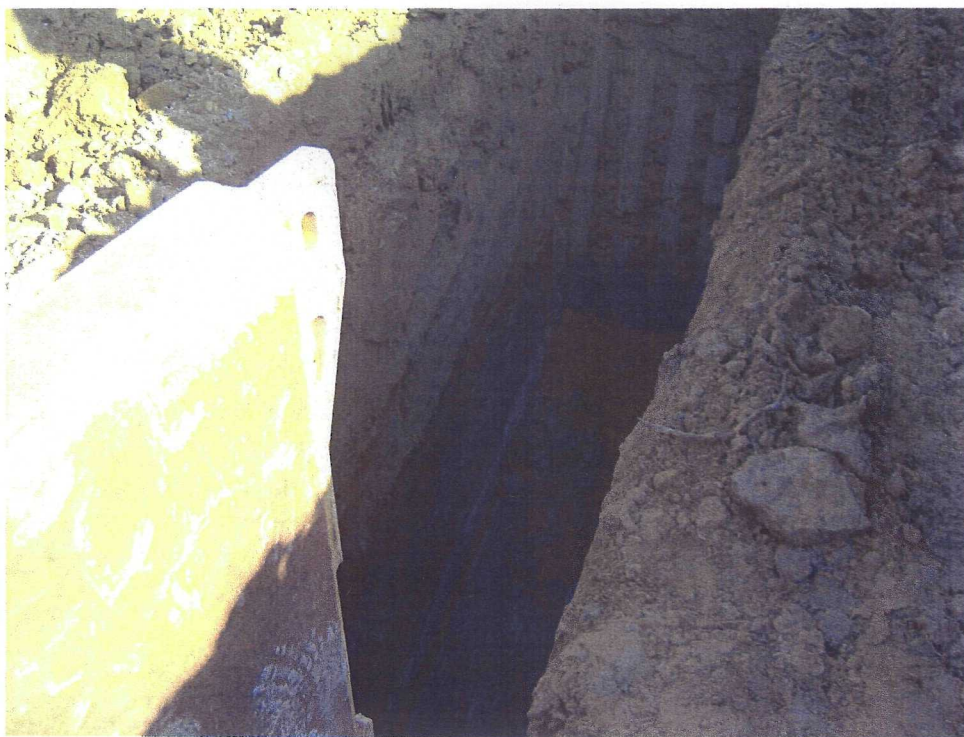
PHOTOGRAPH 44: Excavation of the GWIT collection system east of GWIT Sump #1 continues. Note the GWIT collection pipe is being placed to grade within the gray glacial till layer.

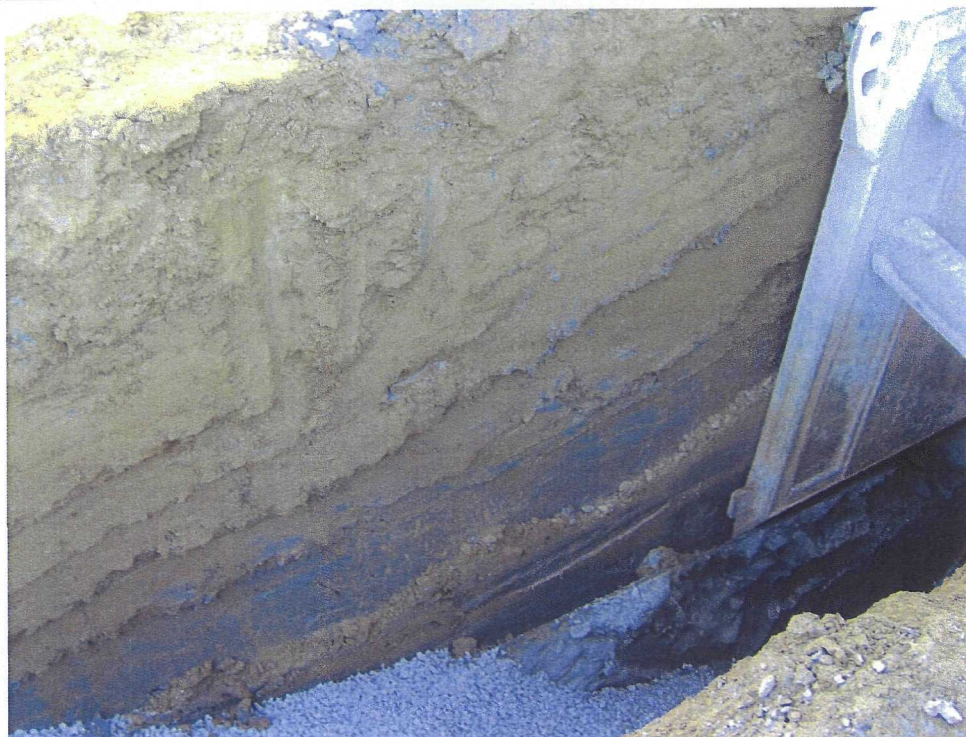
PHOTOGRAPH 45: GWIT collection pipe is placed to grade within the gray glacial till layer east of GWIT Sump #1.

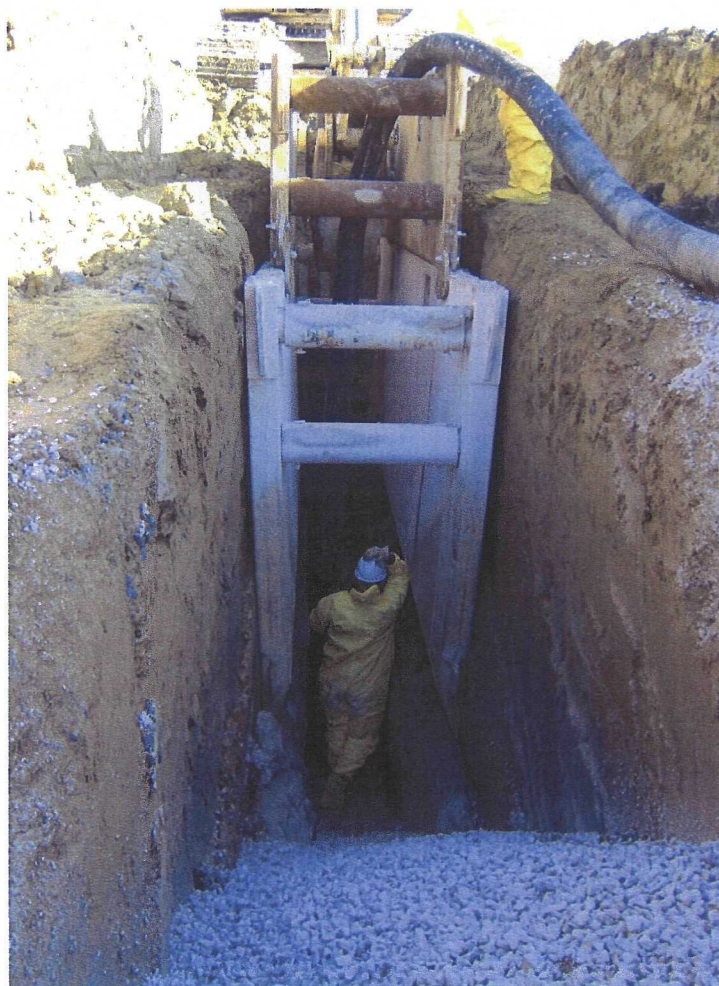
PHOTOGRAPH 46: A second section of trench box was added to assure the safety of employees installing the GWIT collection pipe in the base of the trench.

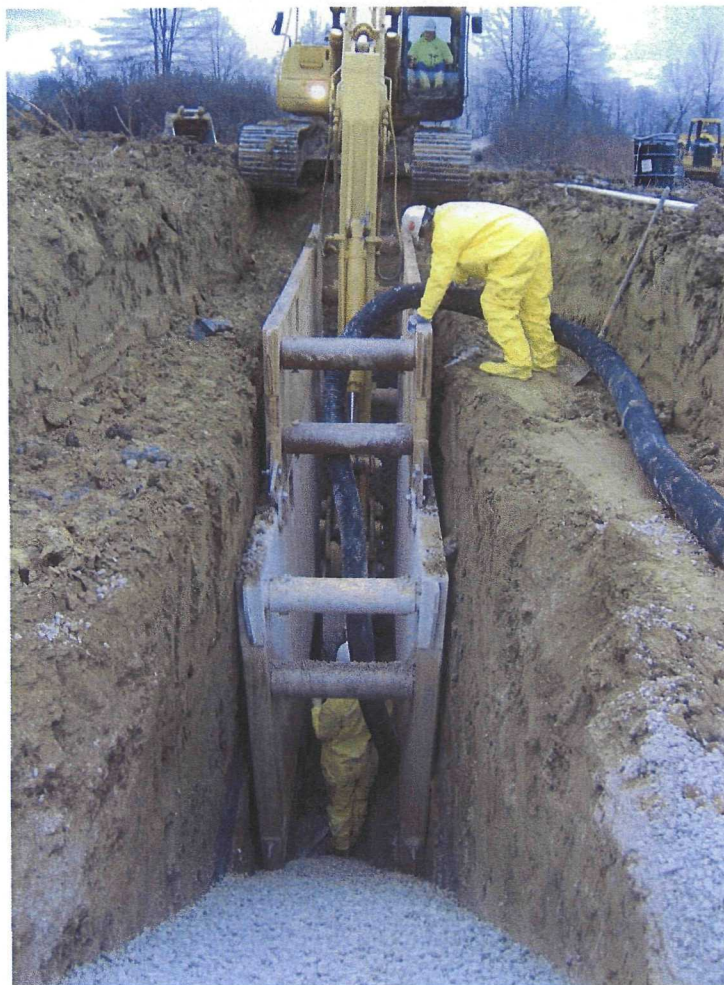
PHOTOGRAPH 47: Installation of the GWIT collection system east of GWIT Sump #1 continues. Depth of trench from grade reaches approx. 18 ft-bgs.

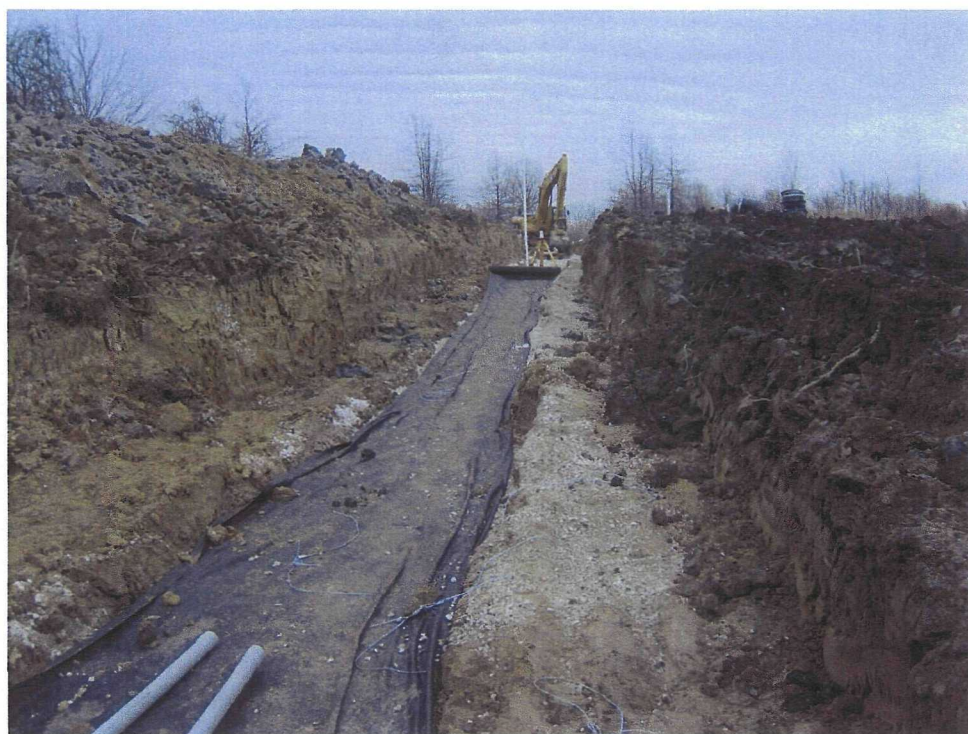
PHOTOGRAPH 48: Section of GWIT collection system completed and backfilled to within 4' of grade and filter fabric installed. Note the electric and forced main pipe has been laid on top of the filter fabric.

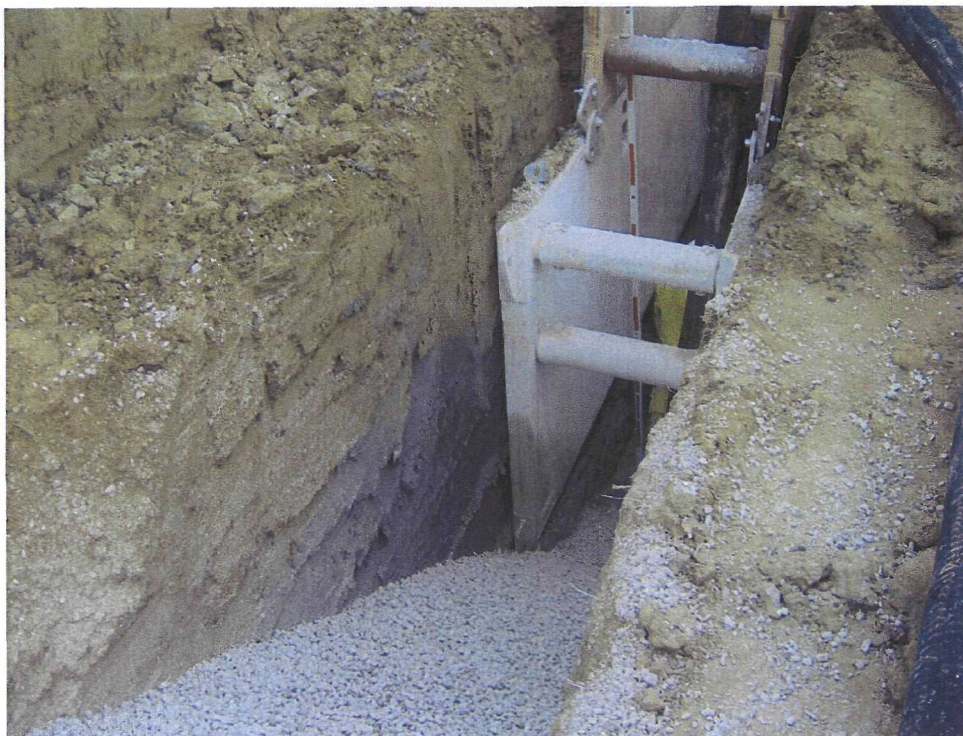
PHOTOGRAPH 49: GWIT collection pipe continues to be place in the gray glacial till layer east of GWIT Sump #1.

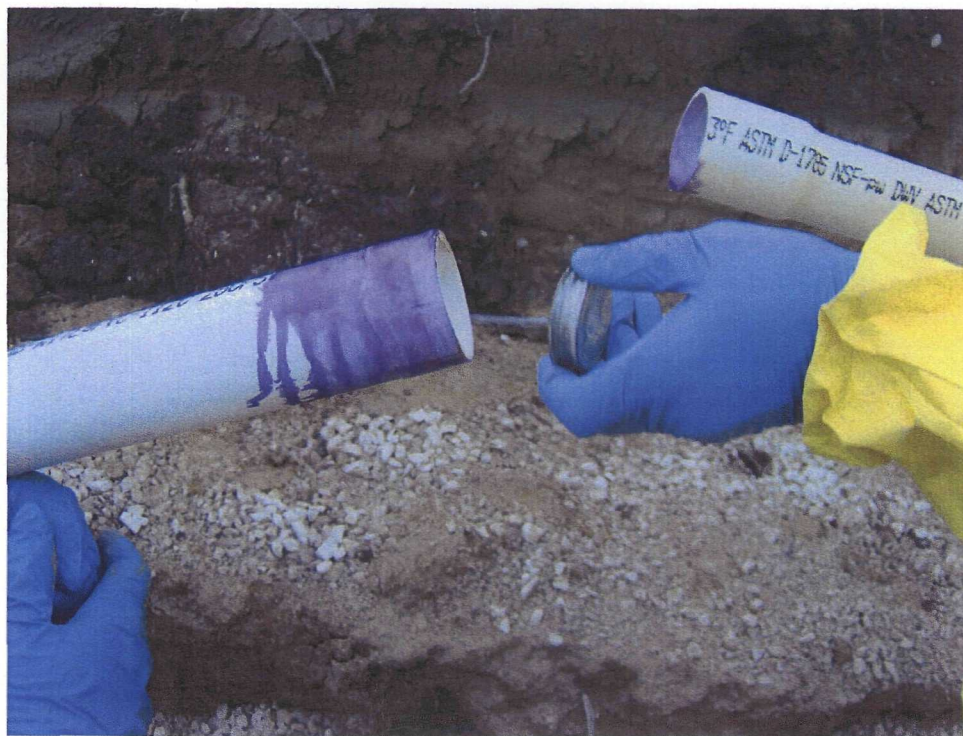
PHOTOGRAPH 50: Electric and forced main pipe ends are first cleaned and then glued east of GWIT Sump #1.

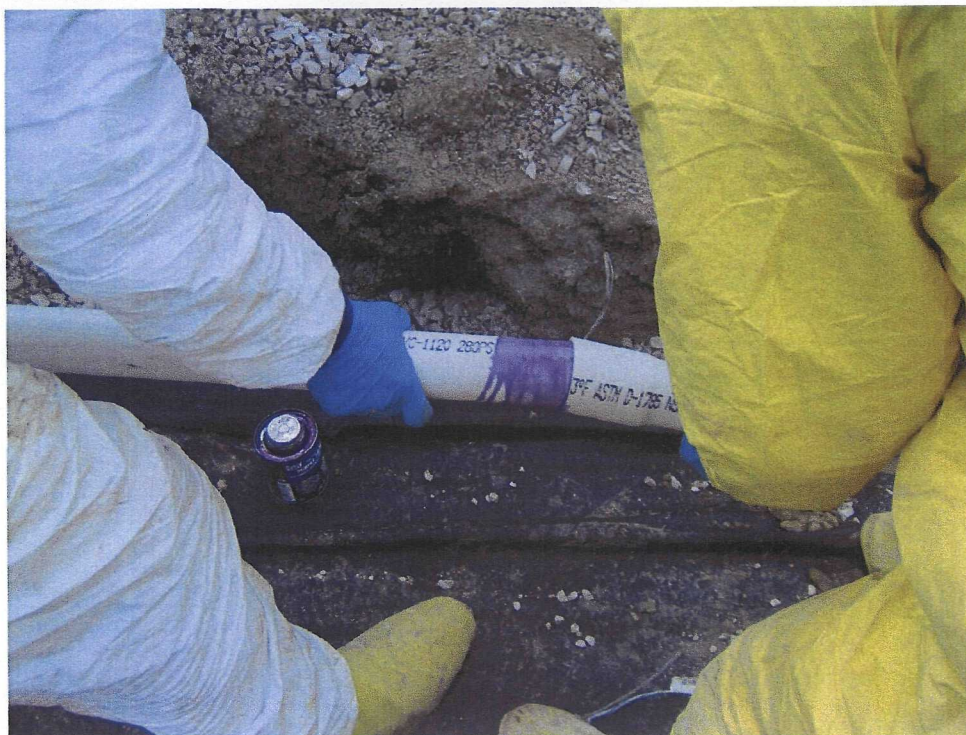
PHOTOGRAPH 51: Section of PVC pipe is fitted together after it has been cleaned and glued. Note the glued PVC pipes are then placed on top of filter fabric.

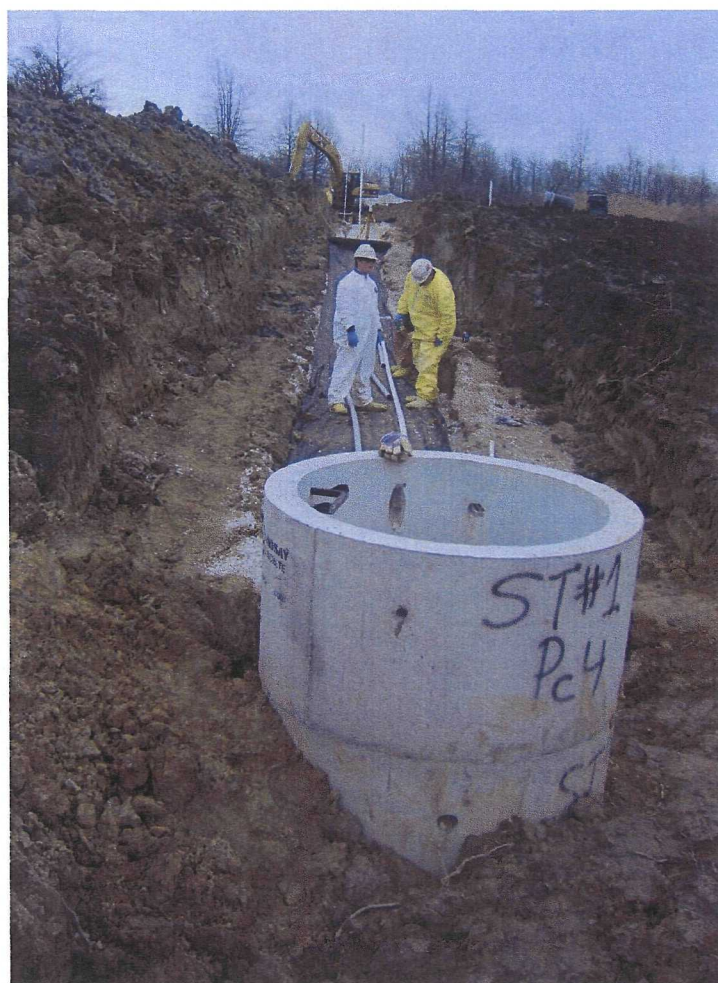
PHOTOGRAPH 52: Perspective photograph of the GWIT collection system installation east of GWIT Sump #1 before backfilling.

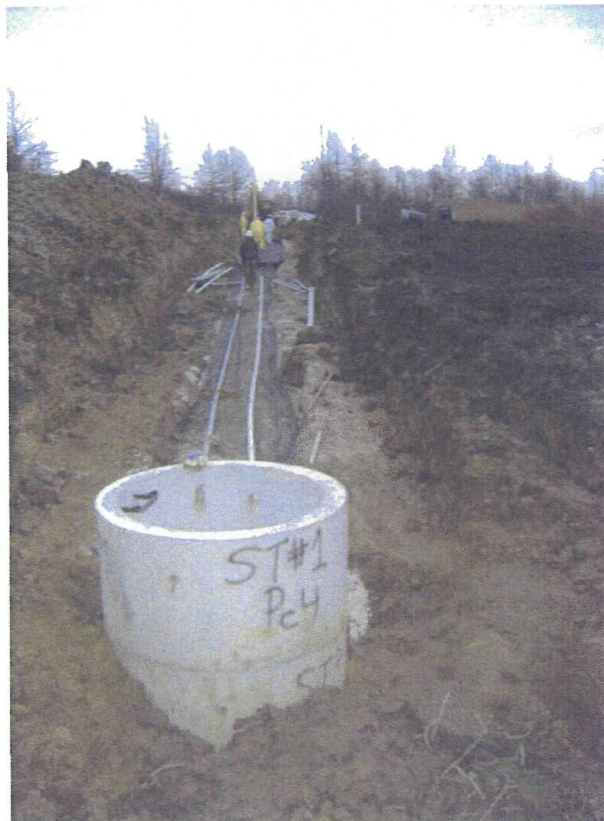
PHOTOGRAPH 53: PVC pipe continues to be cleaned and glued east of GWIT Sump #1.

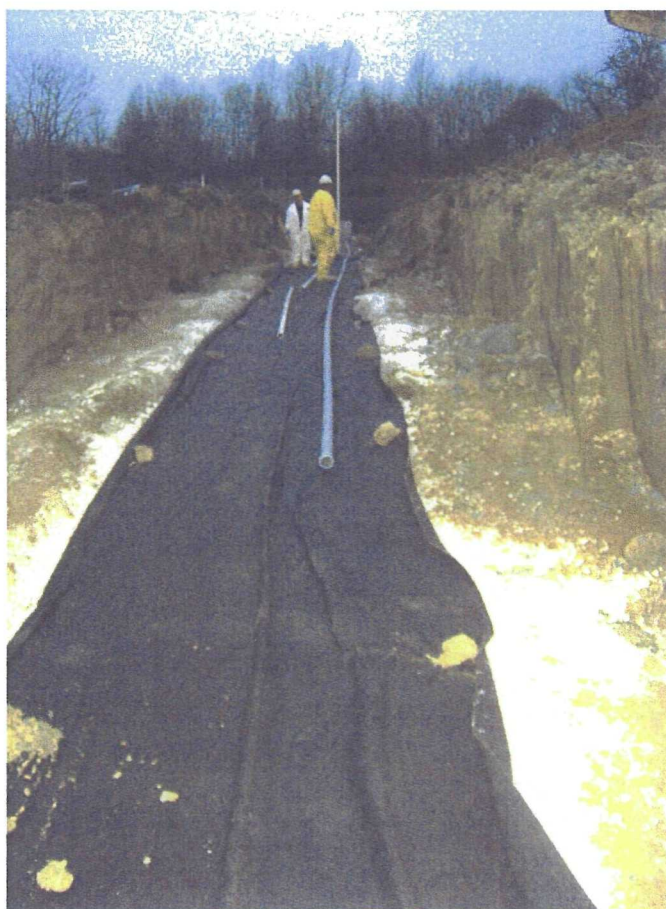
PHOTOGRAPH 54: Section of the GWIT collection system has been installed and filter fabric and PVC pipe is placed before installation.

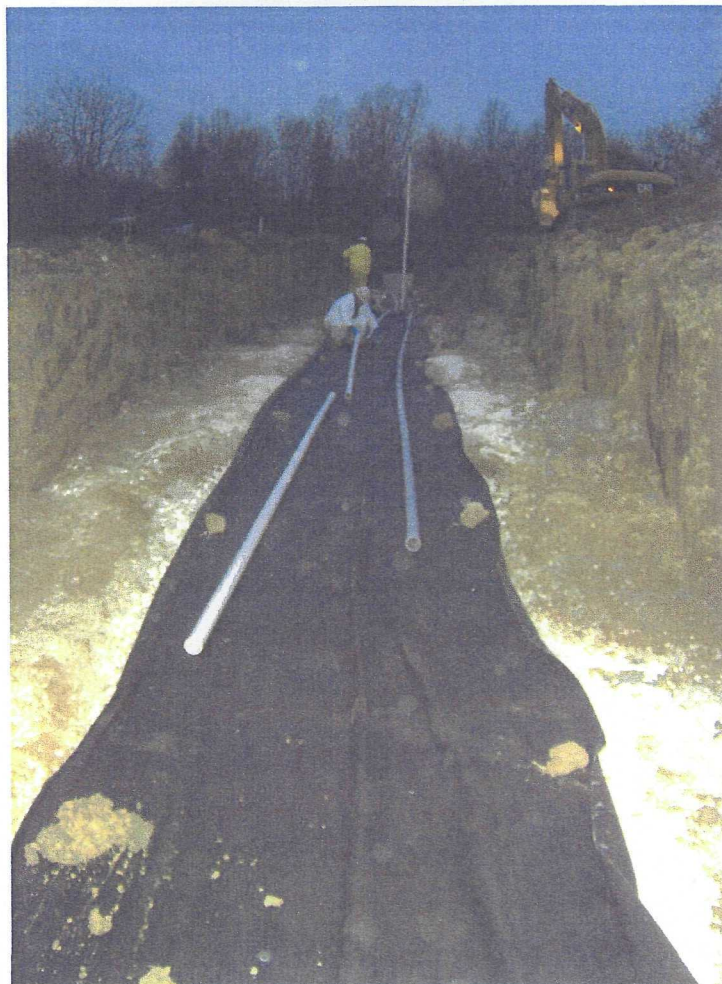
PHOTOGRAPH 55: Employees protected the section of GWIT collection pipe installed the shift at the end of each shift.

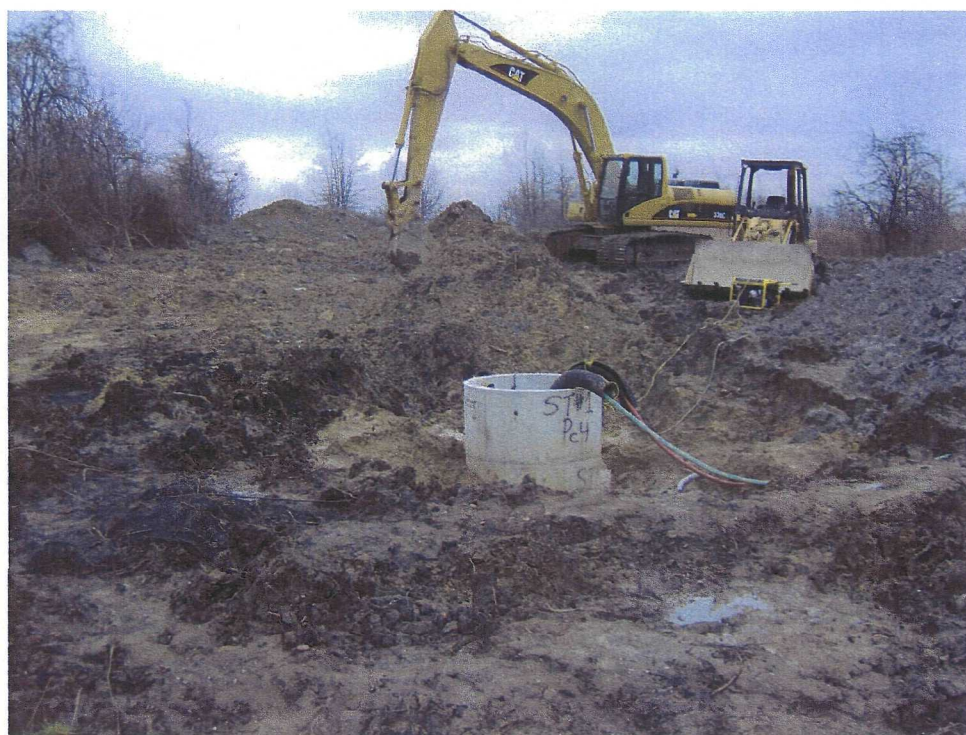
PHOTOGRAPH 56: Backfilling of the GWIT collection system east of GWIT Sump #1. Note the submersible pump discharge hose exiting GWIT Sump #1. Each morning water was pumped from this GWIT Sump and discharged to the east into the Waste Water Treatment GWIT Sump.

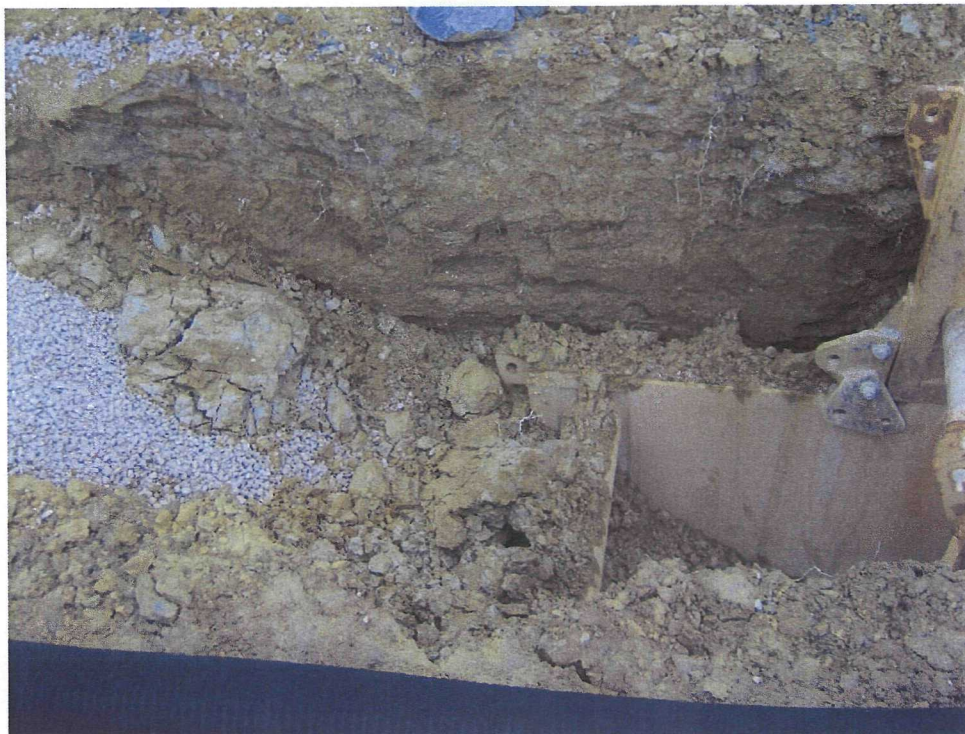
PHOTOGRAPH 57: Approximately 300' east of GWIT Sump #1 ground became very wet and trench cave-in's occurred regularly during the installation of this section of the GWIT.

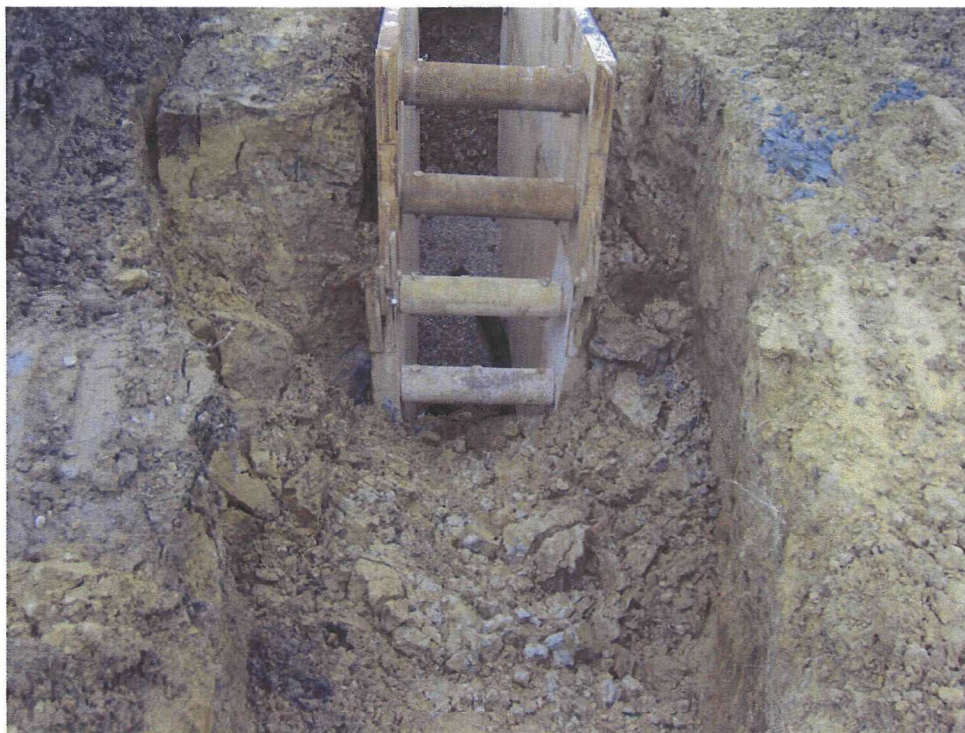
PHOTOGRAPH 58: Cave-in encountered east of GWIT Sump #1.

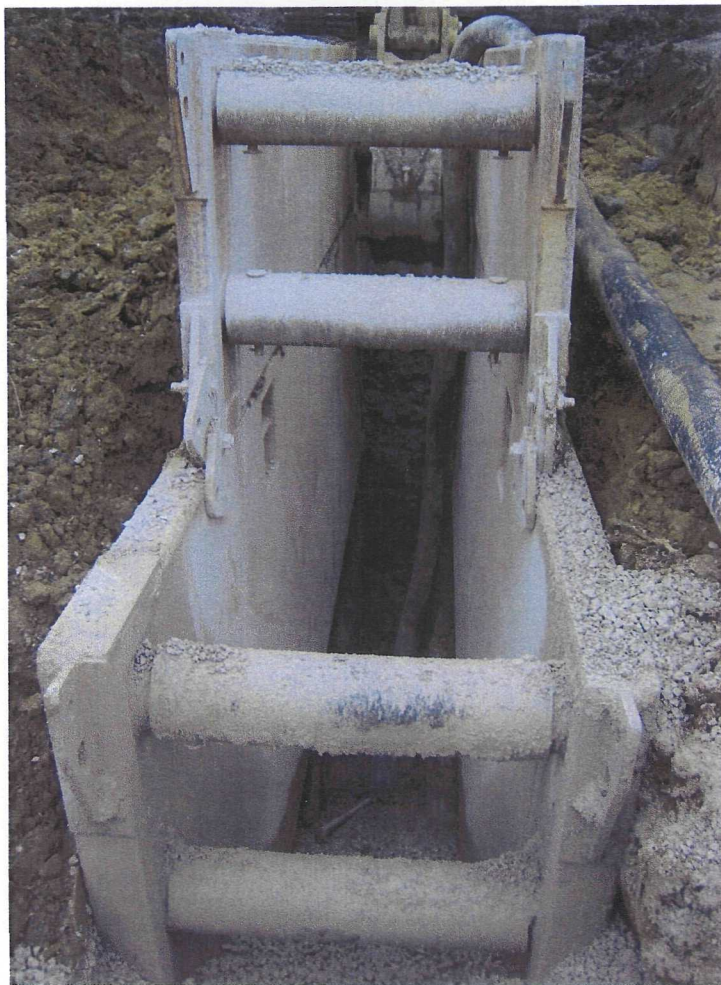
PHOTOGRAPH 61: GWIT collection system continues to be installed east of GWIT Sump #1.

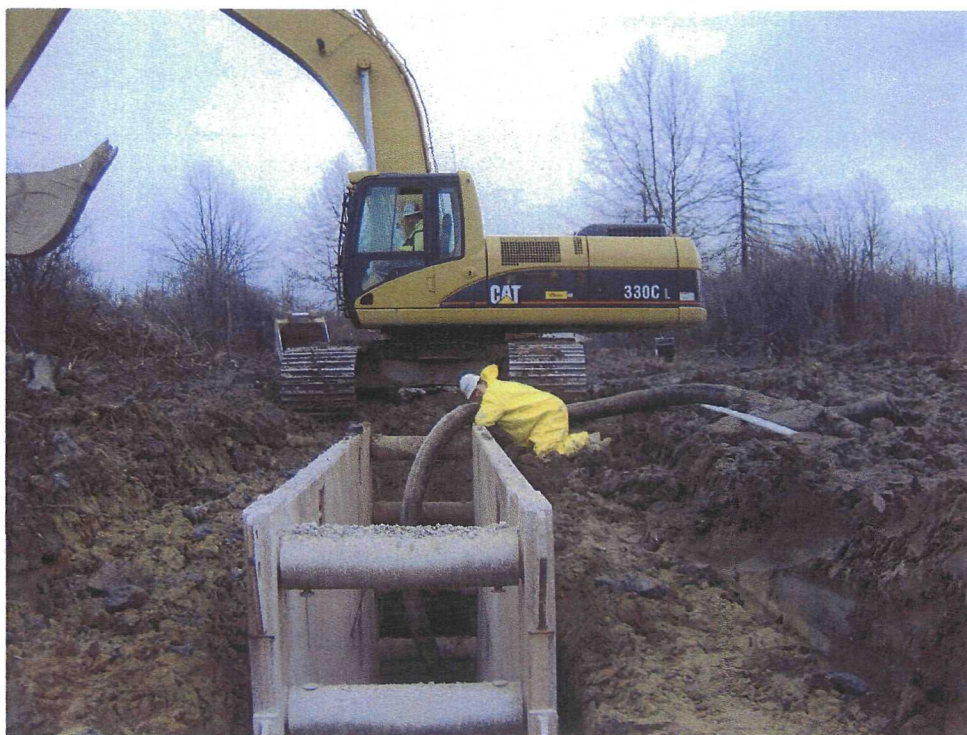
PHOTOGRAPH 62: Perspective photograph of the installation of the GWIT collection system east of GWIT Sump #1.

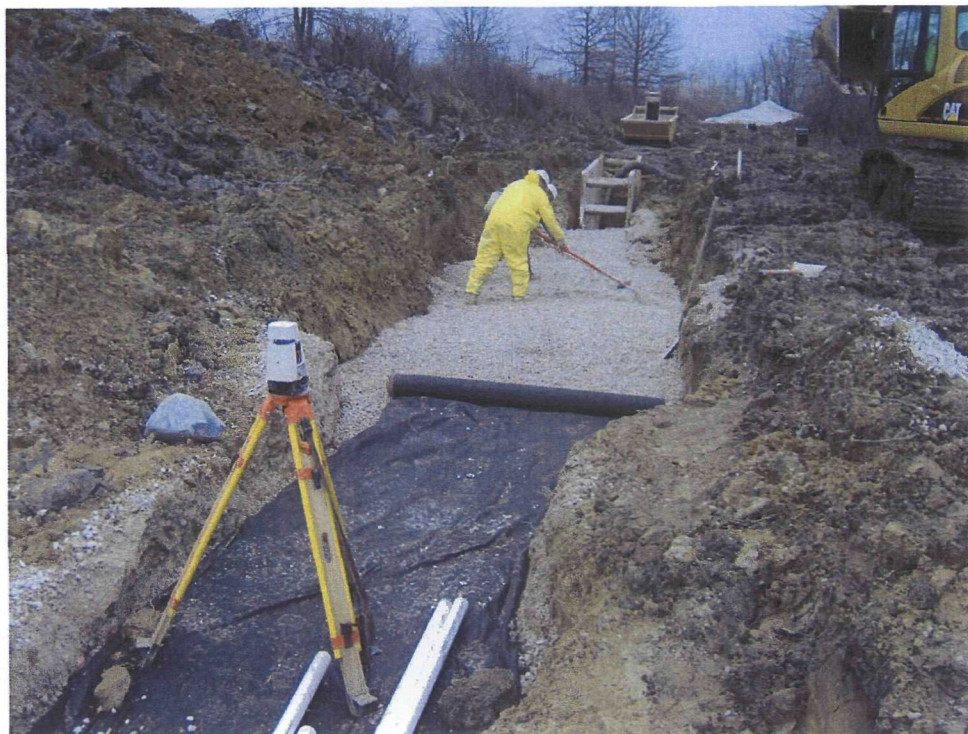
PHOTOGRAPH 63: Gravel is raked flat 4' below grade. Note the laser level that was used to place GWIT pipe on a 5% grade.

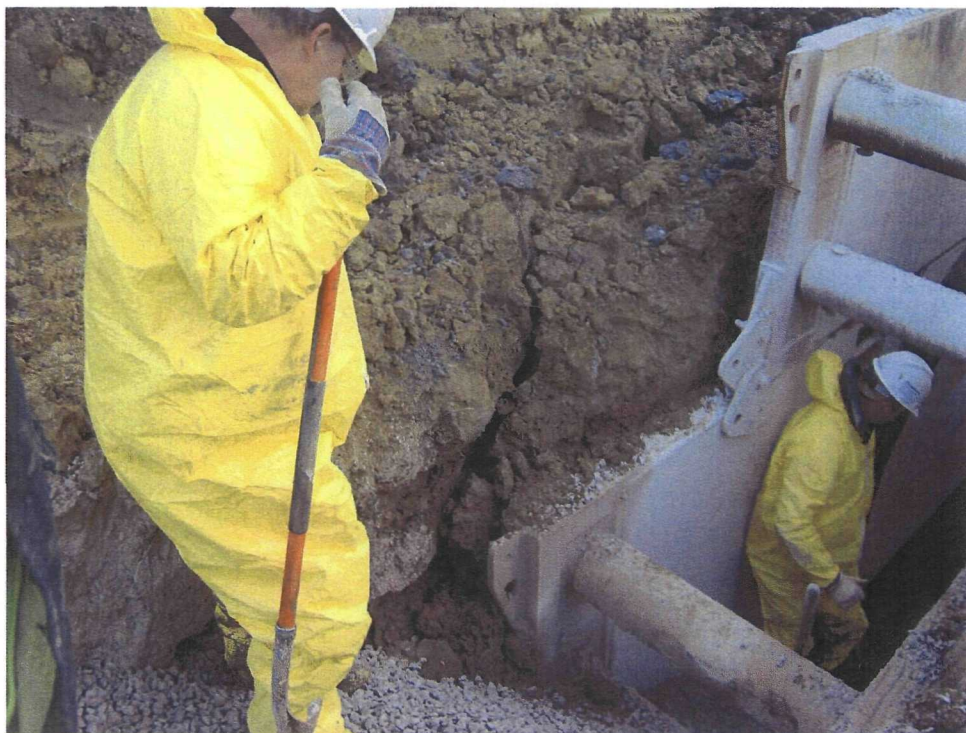
PHOTOGRAPH 64: Employee working inside the trench box at a depth of approximately 17 ft-bgs. Photograph taken east of GWIT Sump #1.

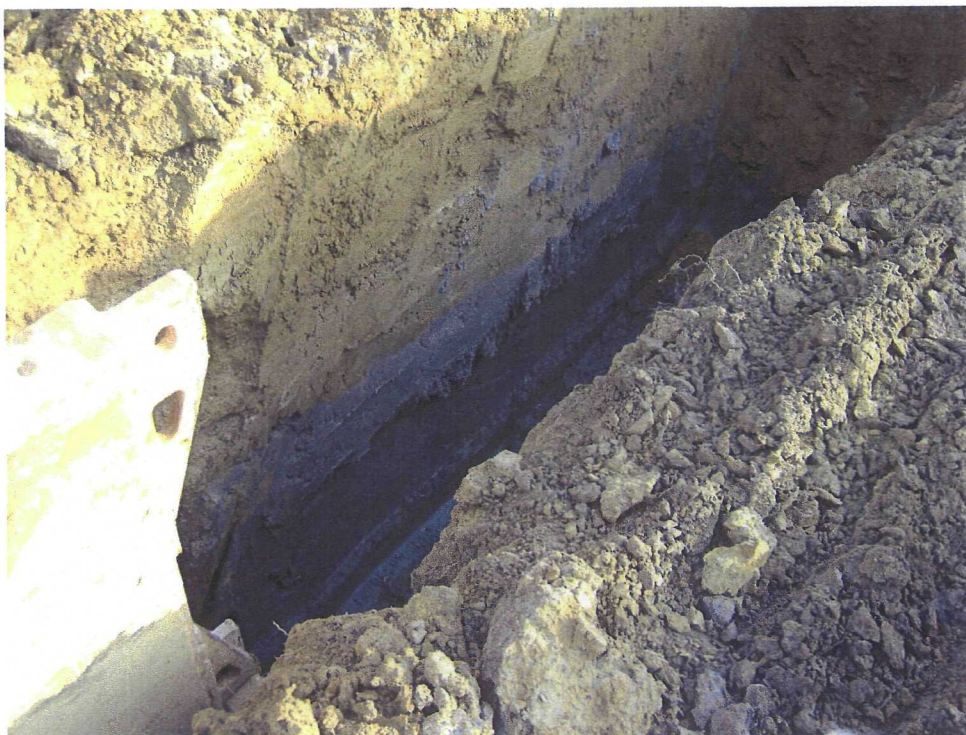
PHOTOGRAPH 65: GWIT collection pipe is placed within the gray glacial till layer.

As shown on the boring logs, the subsurface conditions in the area west of State Road are similar to the geologic conditions on the east side, where the GWIT has been installed. The depth of the gray glacial till is approximately 8-15 ft below ground surface. Above the till is the brown lacustrine soil.

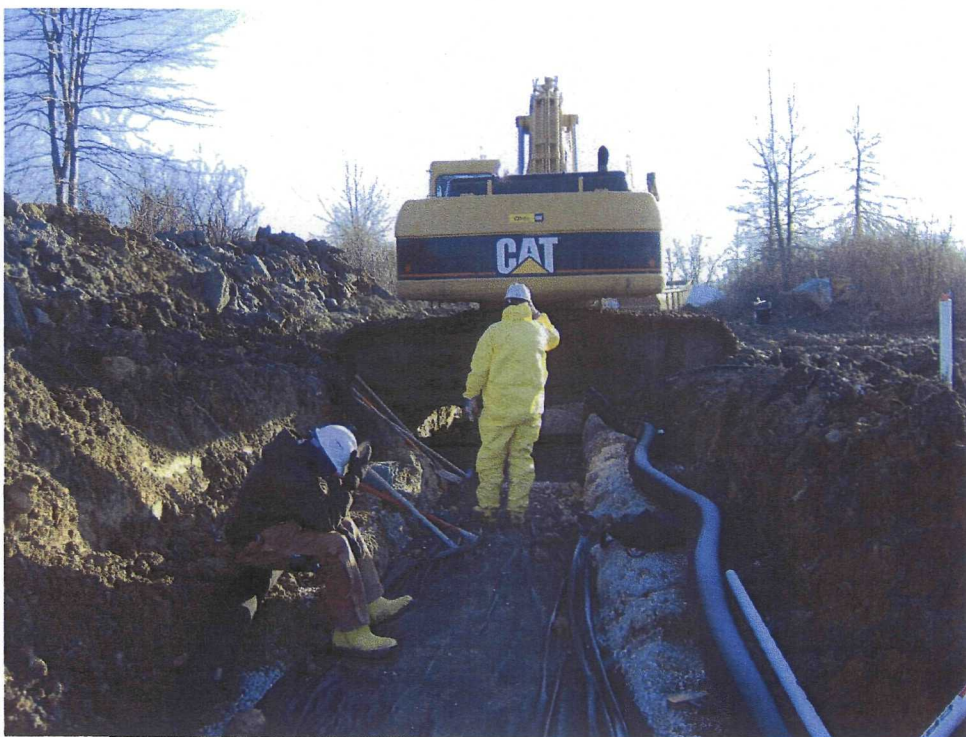
PHOTOGRAPH 66: Track hoe positioned across the trench to excavate cave-in material that fills the trench.

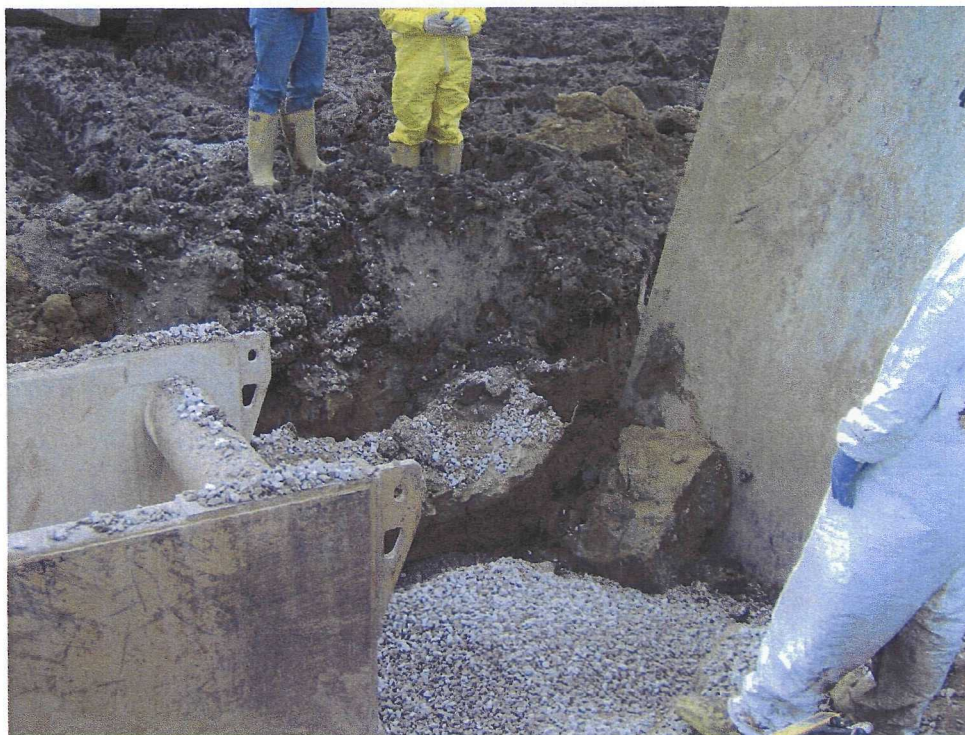
PHOTOGRAPH 67: A steel plate was placed at the limit of the eastern limit of the excavation to prevent cave-ins over night. The trench box was backfilled with gravel. Cave-in's still occurred.
